January 12, 2021

Updated, January 25, 2021

**Re:** Lot 1, 375 Village Bay Road, tree assessment of significant trees

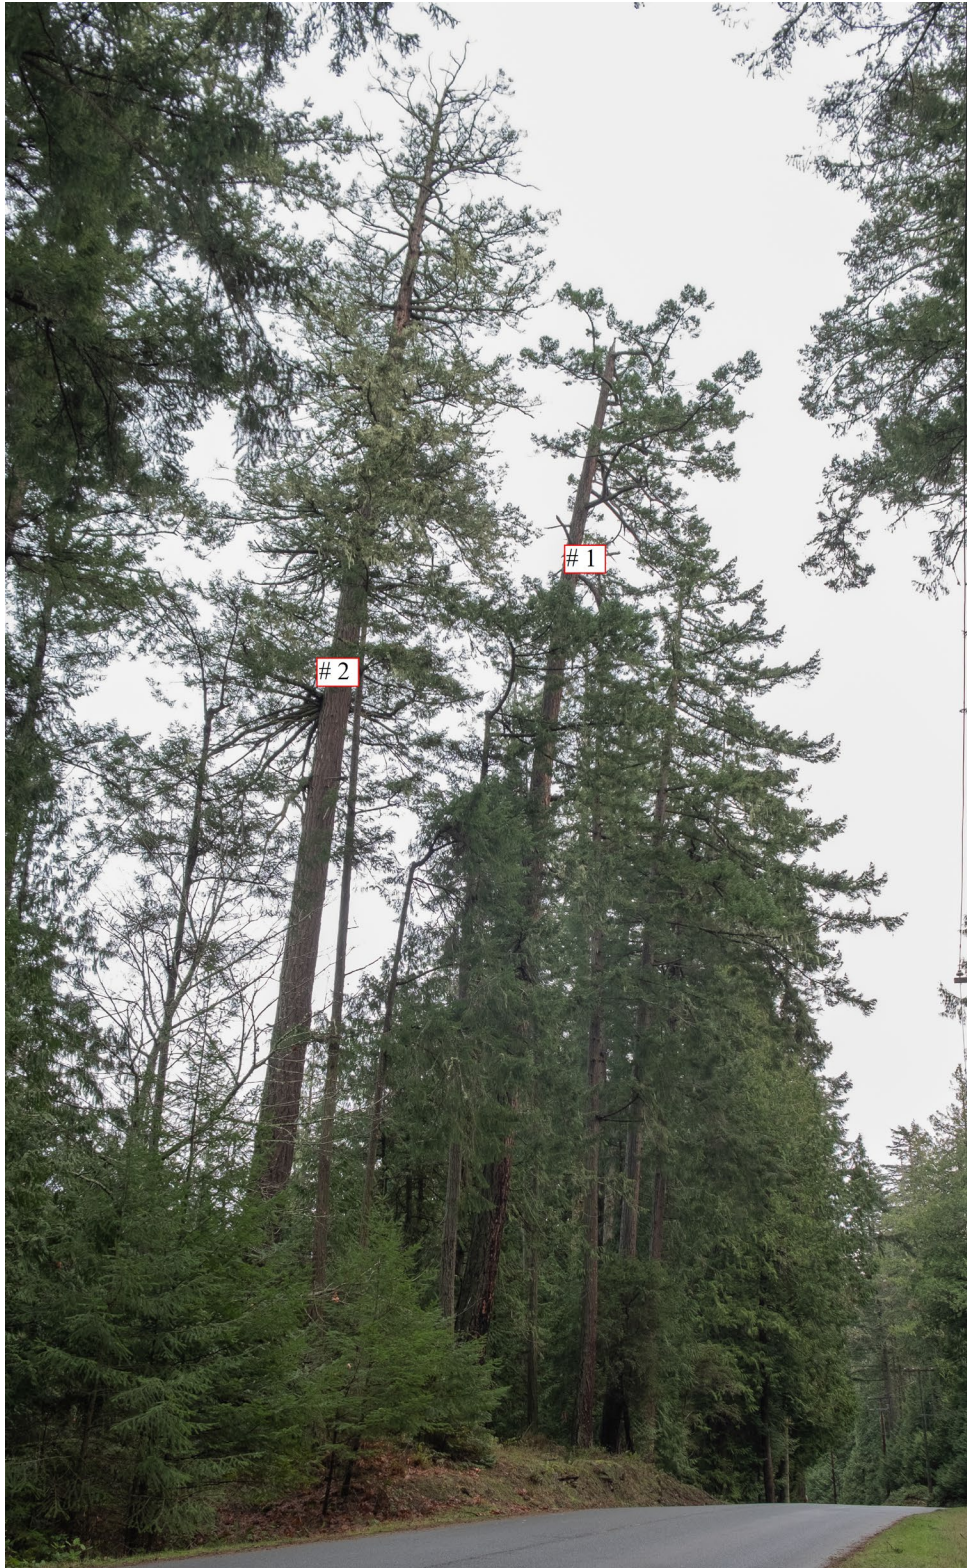
Tree # 1: Douglas fir with a trunk diameter at breast height (DBH) of 142 centimeters and a height of 42 meters. It is located adjacent to the road at the southeast corner of this lot. The tree is in fair health with normal foliage colour, size and density; foliage is limited to the upper canopy. The top of the tree broke off in the past. The tree has a slight lean toward the south southeast; no indications that it shifted recently.

A past forest fire has scarred the bark, on the lower trunk, on the roadside (south). There are horizontal cuts in the bark on the east and west side of the trunk, about 1.5 meters up. It is likely from hardware attached to the trunk in the past. I also found a couple of old scars on the trunk 0.5 meters above ground on the west and south side. I found no visual signs of root rot

I was concerned that the external defects extended into the trunk. To verify or disprove this, I drilled the area with a Rhinntech Resistograph®<sup>1</sup> to determine if internal decay or defects was present in the trunk; none was found. The external defects impact on structural integrity is minor.

Tree # 2: Douglas fir with a DBH of 155 centimeters and a height of 53 meters; it is adjacent to tree number one. It is in poor and declining health. The foliage size is normal; the foliage colour is dull green. The foliage density is sparse, particularly in the upper canopy, where there is little to no live foliage.

I found no visual indication of the trunk or root decay. I drilled the trunk to determine if there is internal decay, none was found. The tree is still structurally sound; the risk of tree failure within the next three years is improbable.

Trees number one and two as seen from the southwest

This tree can be preserved, the risk of tree failure within the next three years is improbable<sup>2</sup>, the most likely parts to fail are branches; this is common on Douglas firs. This is a large tree requiring a very large tree protection zone. I recommend that the TPZ (tree protection zone) extends 15 meters out from the trunk (see map).

If the tree continues to decline, it will likely die. Application of water during the summer months would improve its chances of survival. If the tree dies, it should be removed or turned into a wildlife tree. If the desire is to preserve this tree, the TPZ should extend 18 meters out from the trunk (see map).

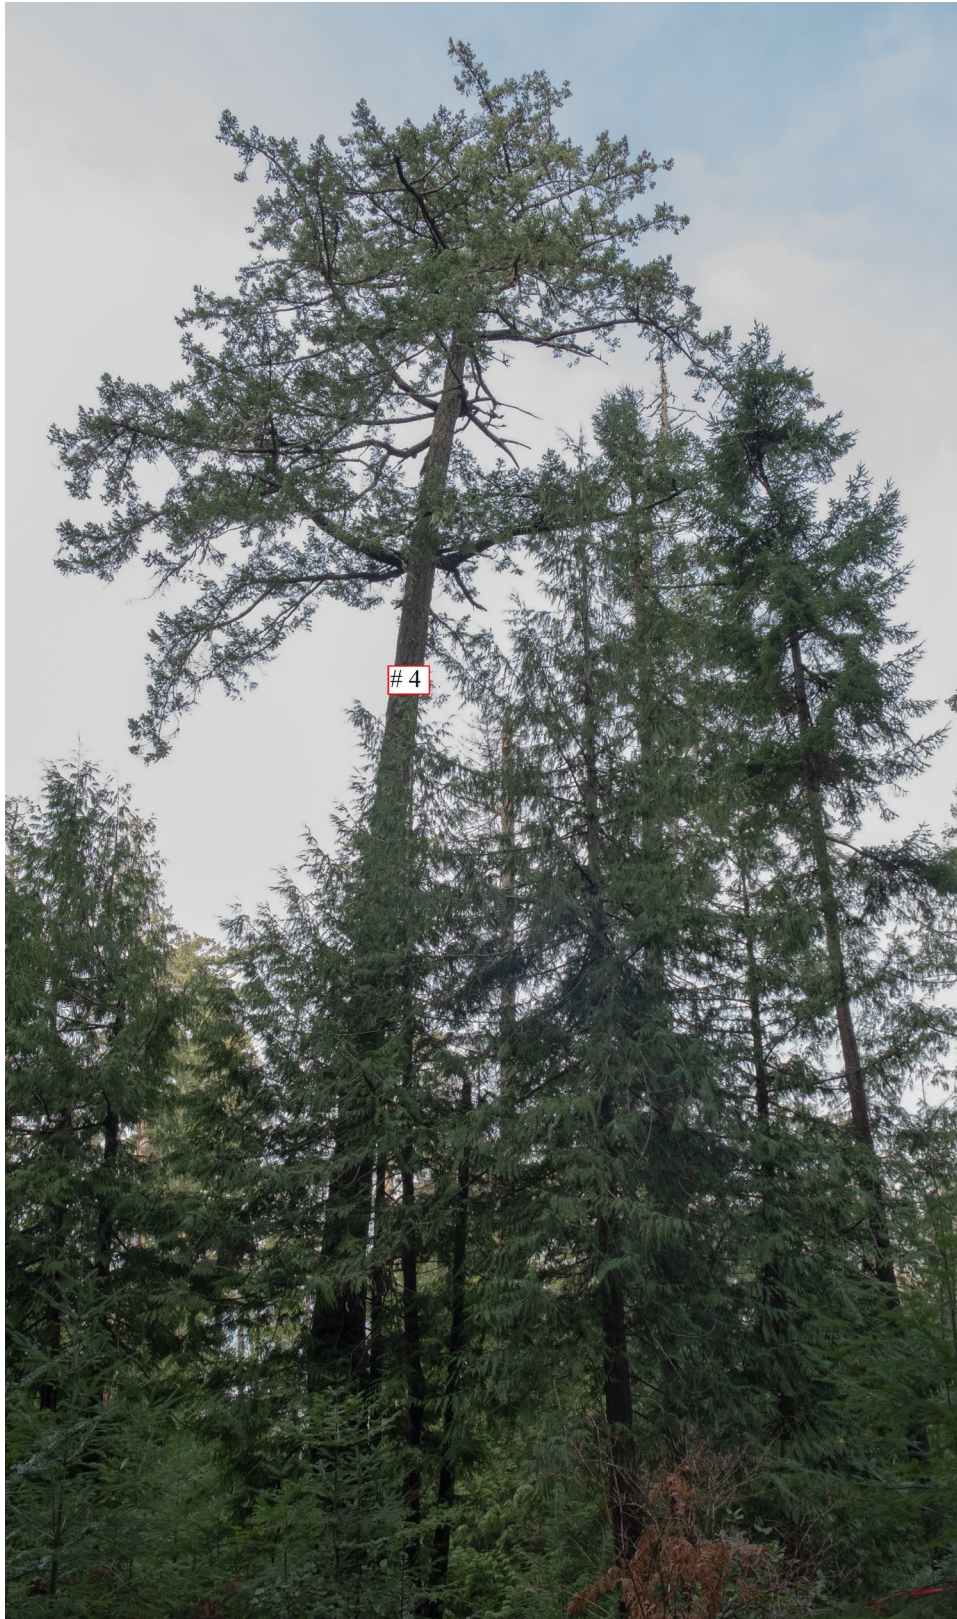
Tree # 4: Douglas fir with a DBH of 128 and a height of 30 meters, situated in from the road on the southwest corner of the lot. It is in fair health with normal foliage size; foliage colour is near normal, and foliage density is slightly sparse. The tree has a slight lean toward the northeast, and the trunk has a bow in the lower trunk and partway up; all minor issues. The canopy has some dead and dying branches throughout.

The lower trunk looks bedraggled; there are fire scars, bulges, swellings and minor sap flow from the trunk. I thoroughly inspected the lower trunk to determine if these surface defects extended into the trunk, possibly affecting this area's structural integrity.

I drilled the lower trunk in three places and drilled the two largest anchoring roots to determine if there is internal decay. I found no internal decay in the places I drilled. The lower tree trunk is structurally sound. The likelihood of tree failure within three years is improbable.

Tree number four as seen from the south

I recommend removing the dead and dying branches to prevent them from falling onto people and property below. To preserve this tree, the TPZ should extend 10 meters out from the trunk (see map). If the other trees in the protection zone will be removed, they should be cut at ground level, leaving the stumps intact. Removal of stumps could make this tree unstable.

Amendment Jan 25, 2021: The TPZ can be oval or offset slightly to provide enough space for the planned road between the tree and the west property line. It is essential to stay at least 7 meters away from the trunk, as closer could increase the risk of tree failure.

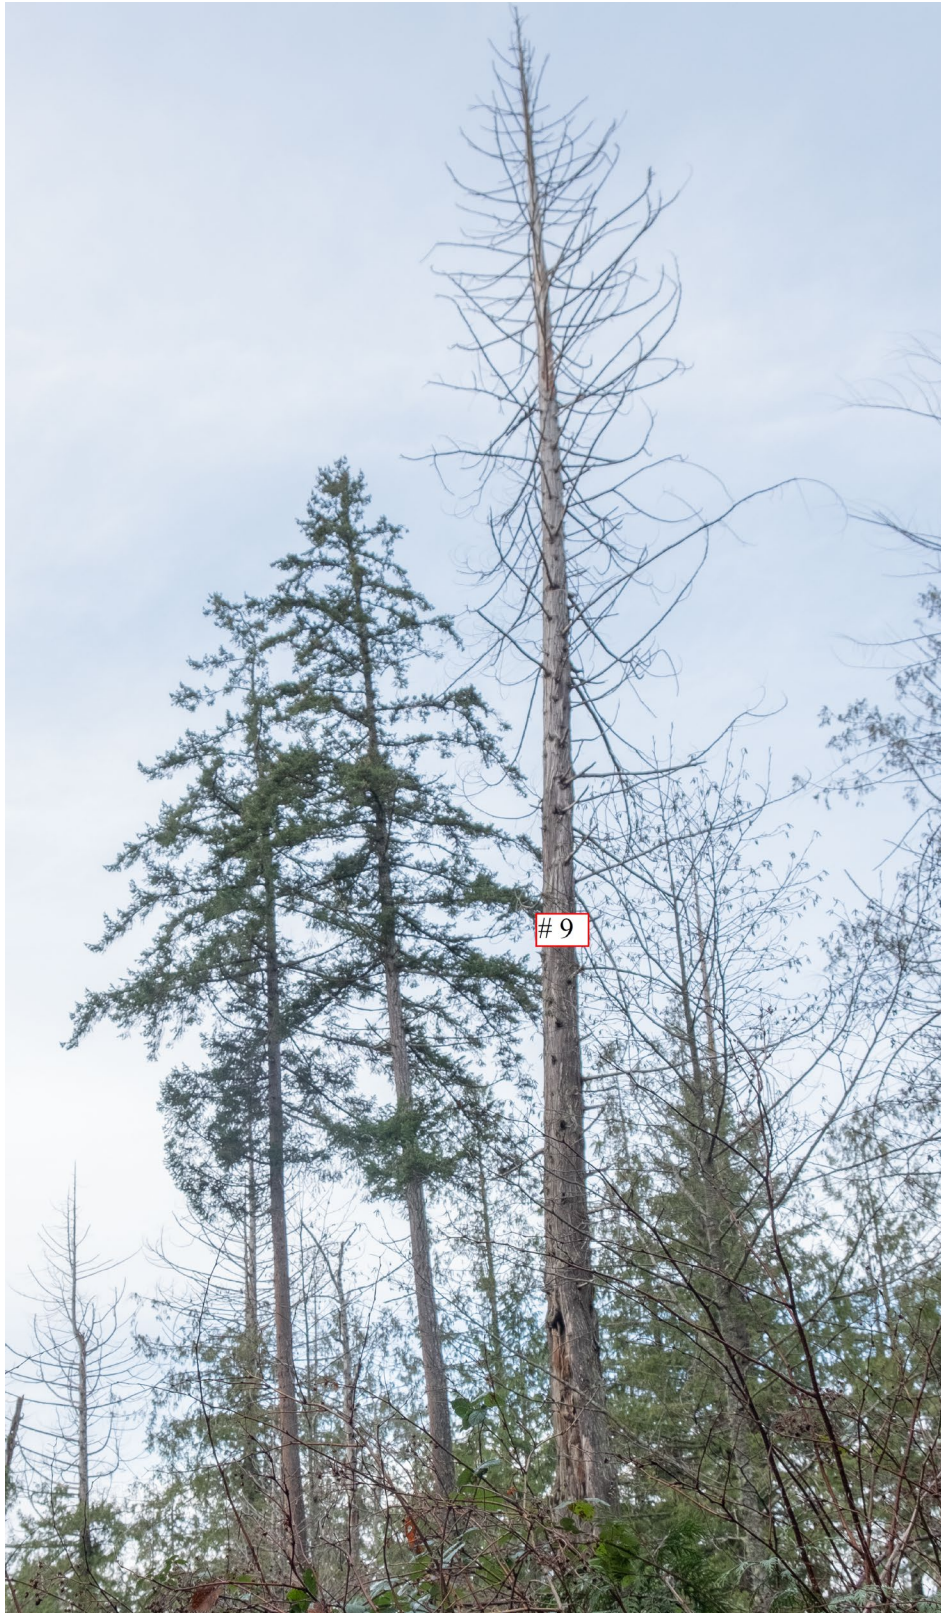
Tree # 9: Dead Western redcedar (*Thuja plicata*) with a DBH of 135 centimeters and a height of 36 meters with a lean toward the northeast. The trunk has a large wound from a past failure a few meters up on the southwest side.

The trunk has extensive internal and external decay and can fail at any time. It will most likely fall toward the northeast. I recommend removing this tree as it can fall onto neighbouring properties; it should be cut at a ground level as it is not safe to climb.

Wildlife tree number nine as seen from the southeast
