09 November 2020

Re: Site Assessment for the Purpose of a Community Onsite Wastewater System for Subdivision Development and Rezoning – 375 Village Bay Road, Mayne Island, BC

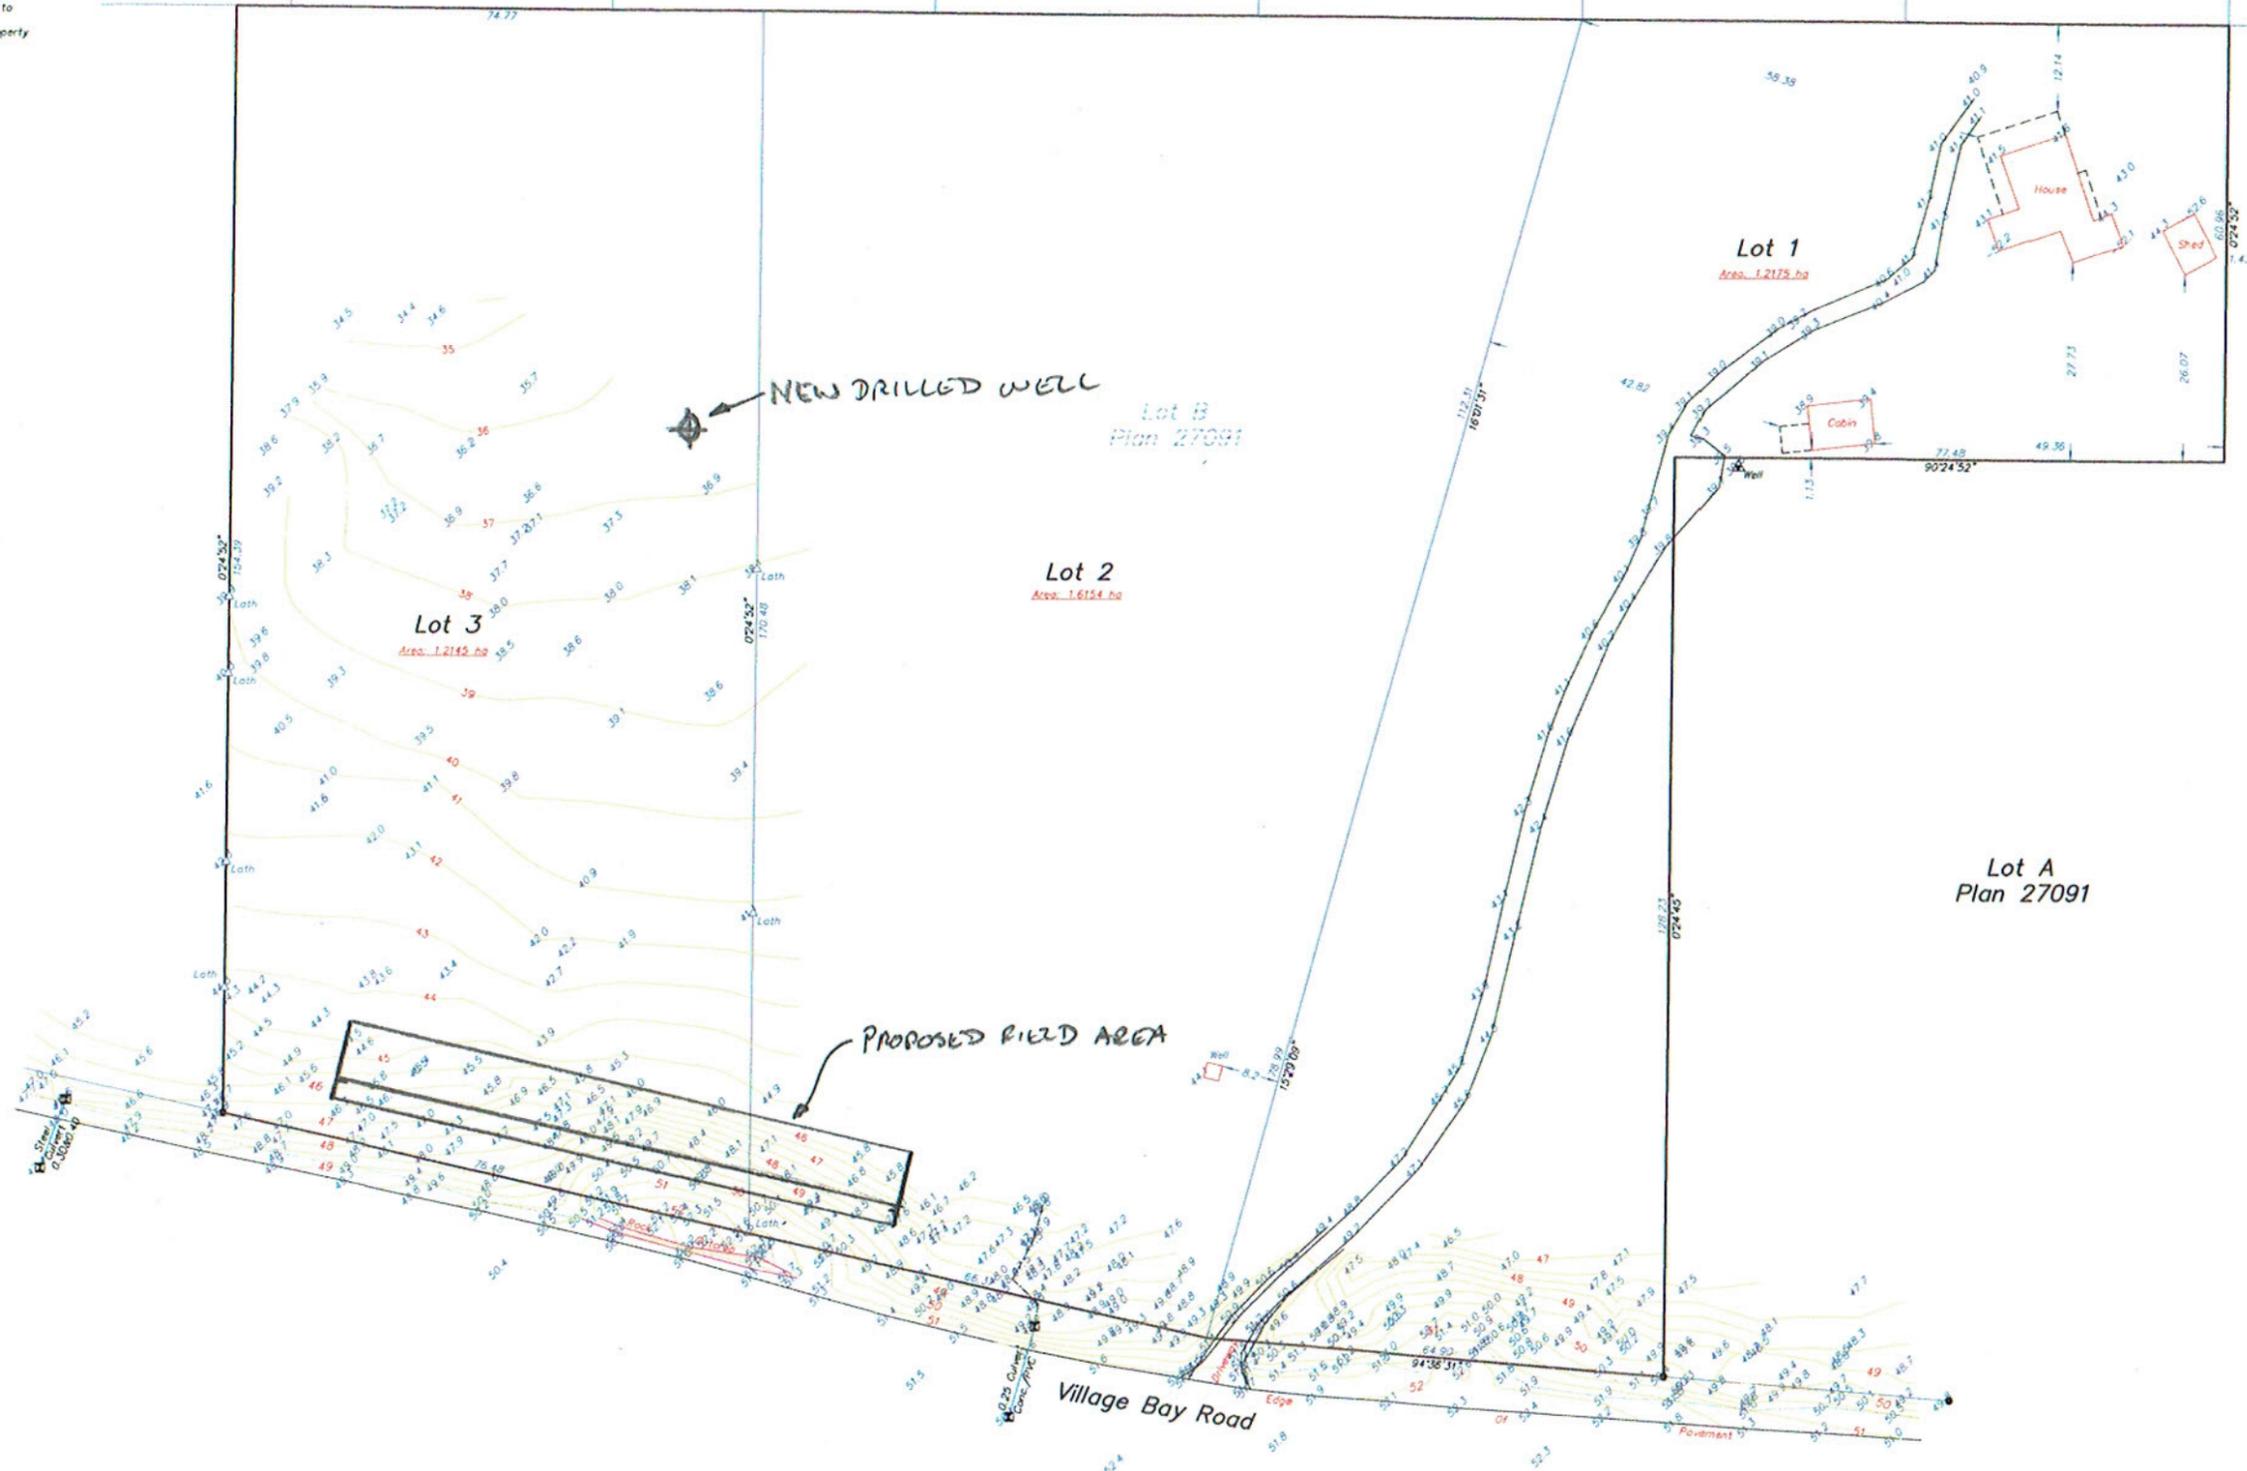
**Proposed Subdivision Of:
 Lot B, Section 7, Mayne Island,
 Cowichan District, Plan 27091,
 P.I.D. 002-552-256**

1. Way Mayenburg Land Survey (Proposed septic field & well are added)
2. Site Plan (Driveway will be relocated to accommodate septic field)
