Wetland Restoration Design Report

For Proposed Subdivision for Affordable Housing of:

Lot B, Section 7, Mayne Island, Plan 27091

Civic Address: 375 Village Bay Road

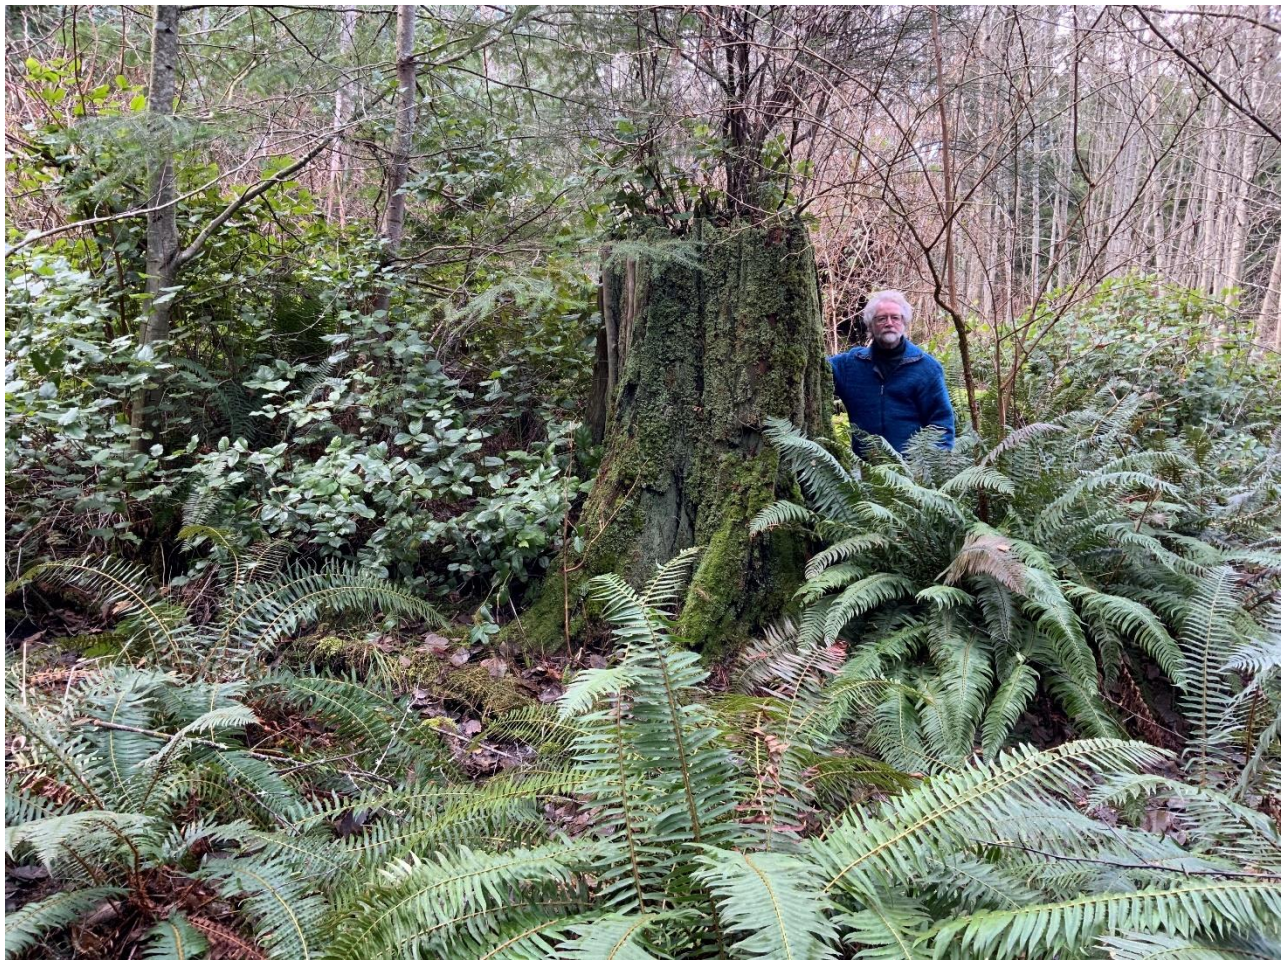
Figure 2. Brian Crumblehulme stands beside a cedar stump 1.47 metres in diameter. This cedar was cut using a cross-cut saw. Springboard notches are visible on the back of the stump.

subject property was first logged around this time, as there is evidence of cross-cut saw logging with springboard notches on old cedar stumps. One cedar stump was measured at 1.47 metres in diameter (Figure 2). The size of the stumps indicates the potential productivity of the site for growing large cedar trees. Such sites are rare in the Southern Gulf Islands. Cedar has great cultural importance for Coast Salish people, and provides important habitat features for a wide variety of species, including nesting habitat for the Western Screech Owl, a species at risk. Most sites in the southern gulf islands that historically supported large cedar swamps (or forested wetlands) have been cleared, drained and converted to agricultural use, with no prospect of restoration in a timeframe that is meaningful with respect to climate change. In this context, any opportunity to restore and provide permanent protection to a forested cedar wetland is significant.

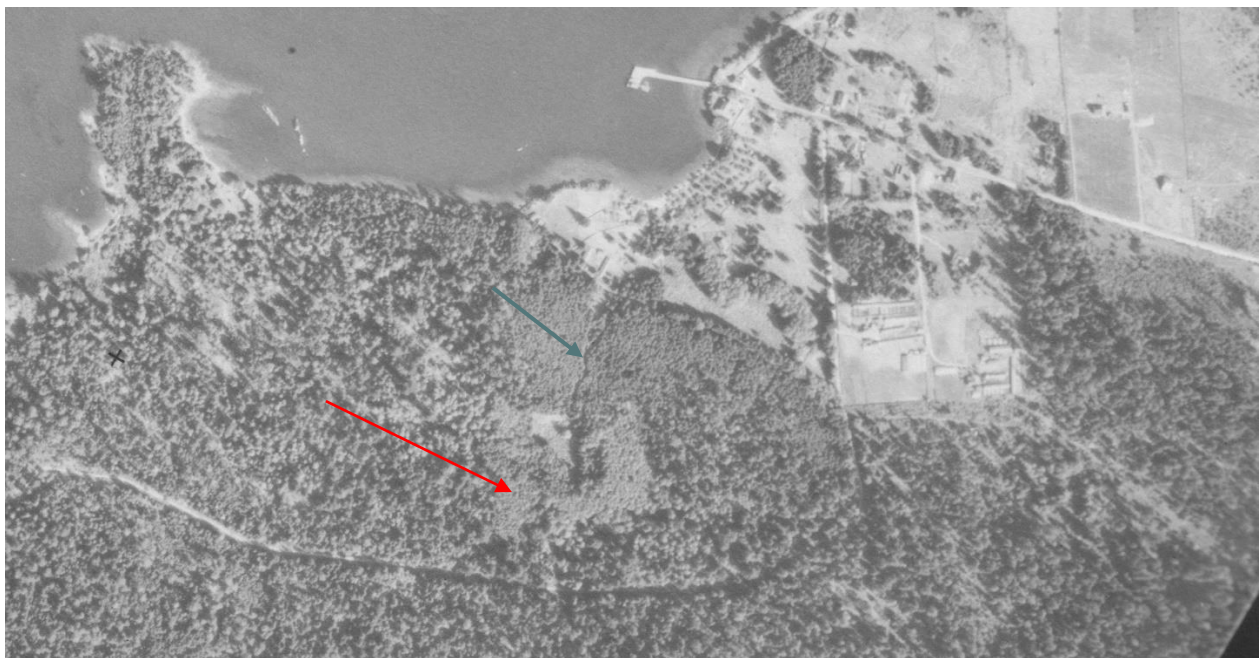
Figure 3. This 1932 air photo of the area shows the outline of an old field that has mostly been allowed to grow up to shrubs (red arrow) and a road leading to it from the farm on the shoreline of Miner's Bay (blue arrow).

The earliest available air photo of 375 Village Bay Road is from 1932 (Figure 3). It shows an intensively farmed area around Miner's Bay. In the area where 375 Village Bay Road is located, the outline of an old field that has mostly been allowed to grow up to shrubs is visible, as is what appears to be an old road leading from the shoreline farms. A small portion of the old field is still clear of vegetation. This suggests that early settlers cleared a field for agricultural use – probably for use as a pasture to graze cattle. Livestock compact moist soils with their hooves and flatten areas that previously had complex micro-topography of pits and mounds. By 1932, the field was already mostly abandoned, with only a small portion still in use at that time, again likely for grazing. Current site conditions suggest the field was abandoned and allowed to grow up to trees because it was too wet for agricultural use.

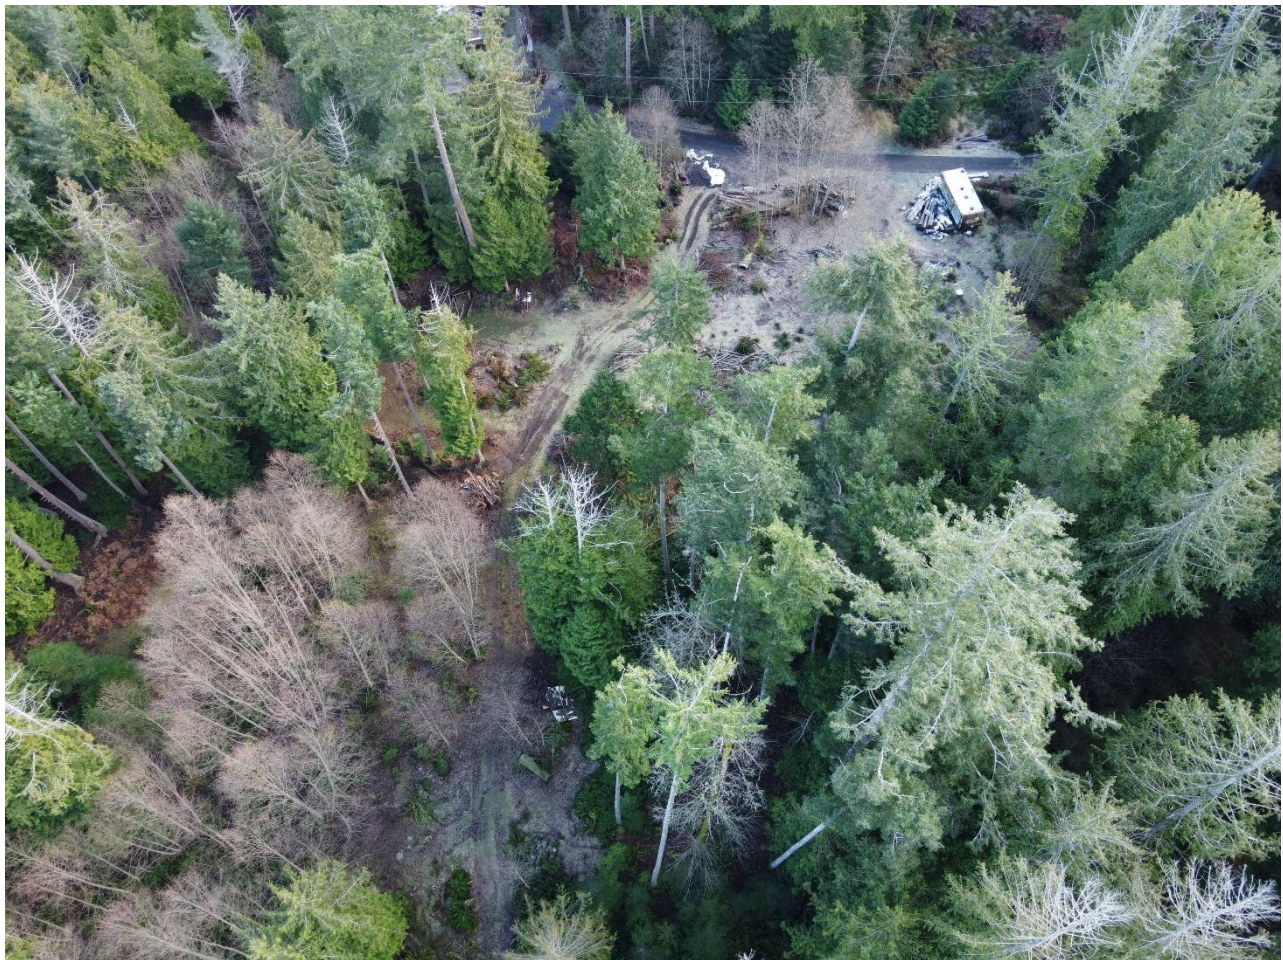
Figure 4. This road leads from the existing driveway west across proposed Lots 2 and 3. It was likely built to provide access for the 2004 logging.

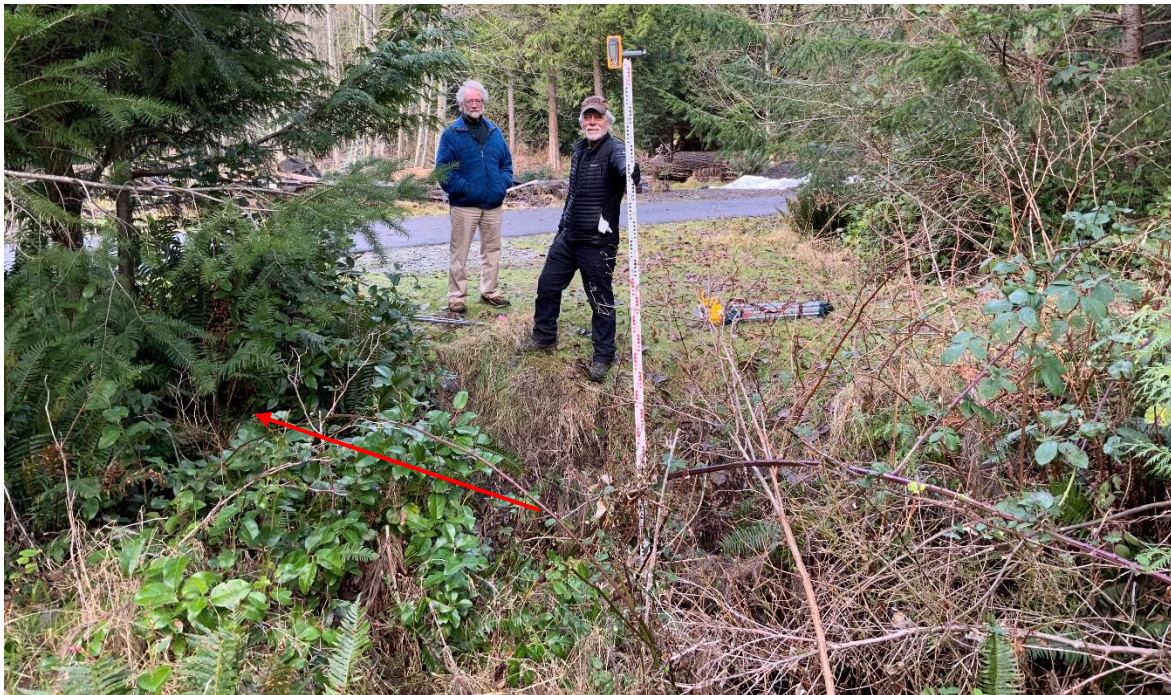
Figure 5. David Brown measures a ditch that is 1.5 metres deep and over 2 metres wide on the east side of the existing driveway on proposed Lot 1. The red arrow shows the direction of water flow in the ditch.

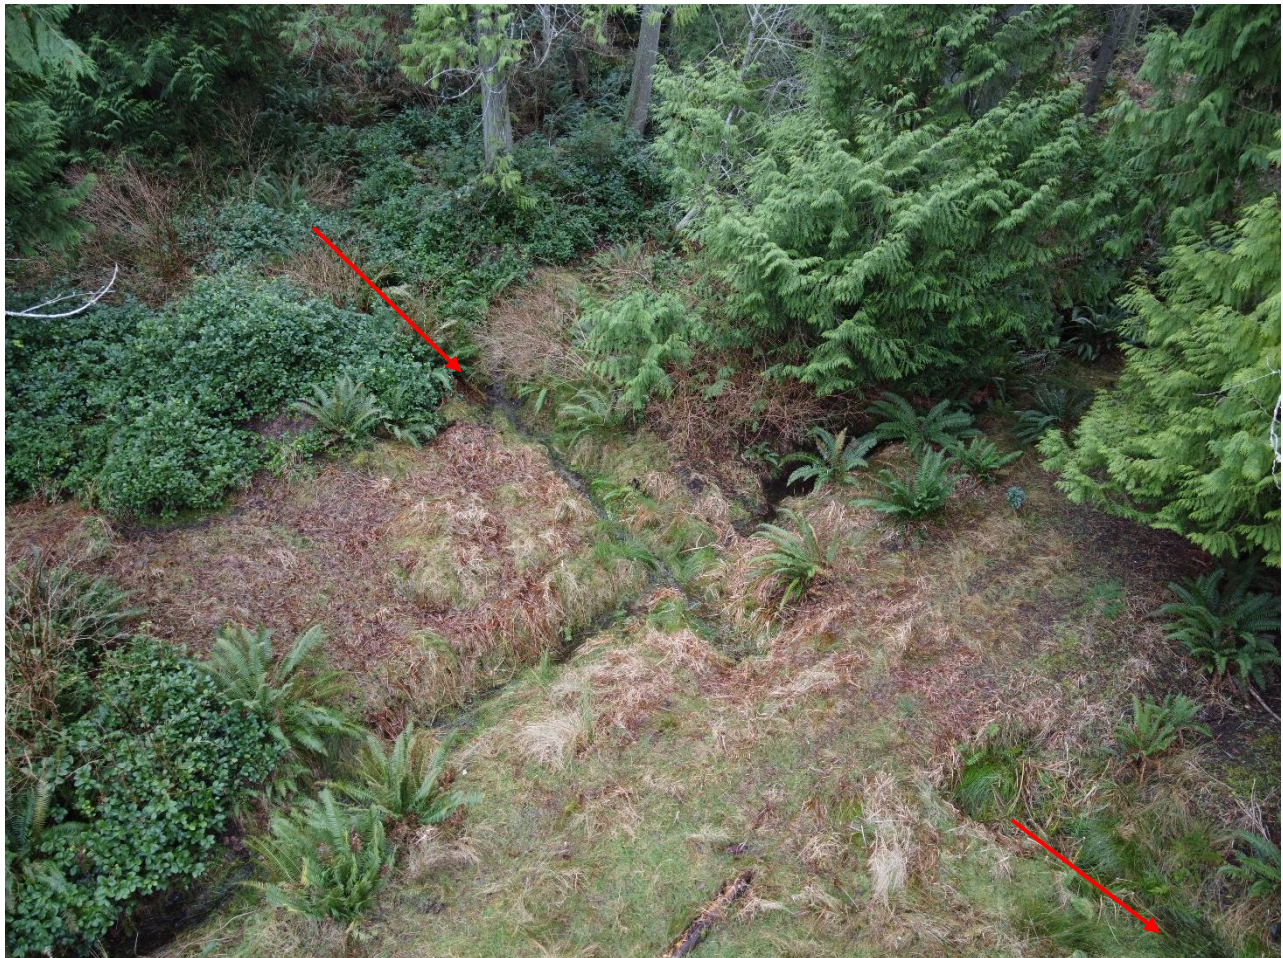
Figure 6. Ditches at right angles to each other that flow all year round indicate a wetland that is actively being drained. Red arrows show the direction of flow.

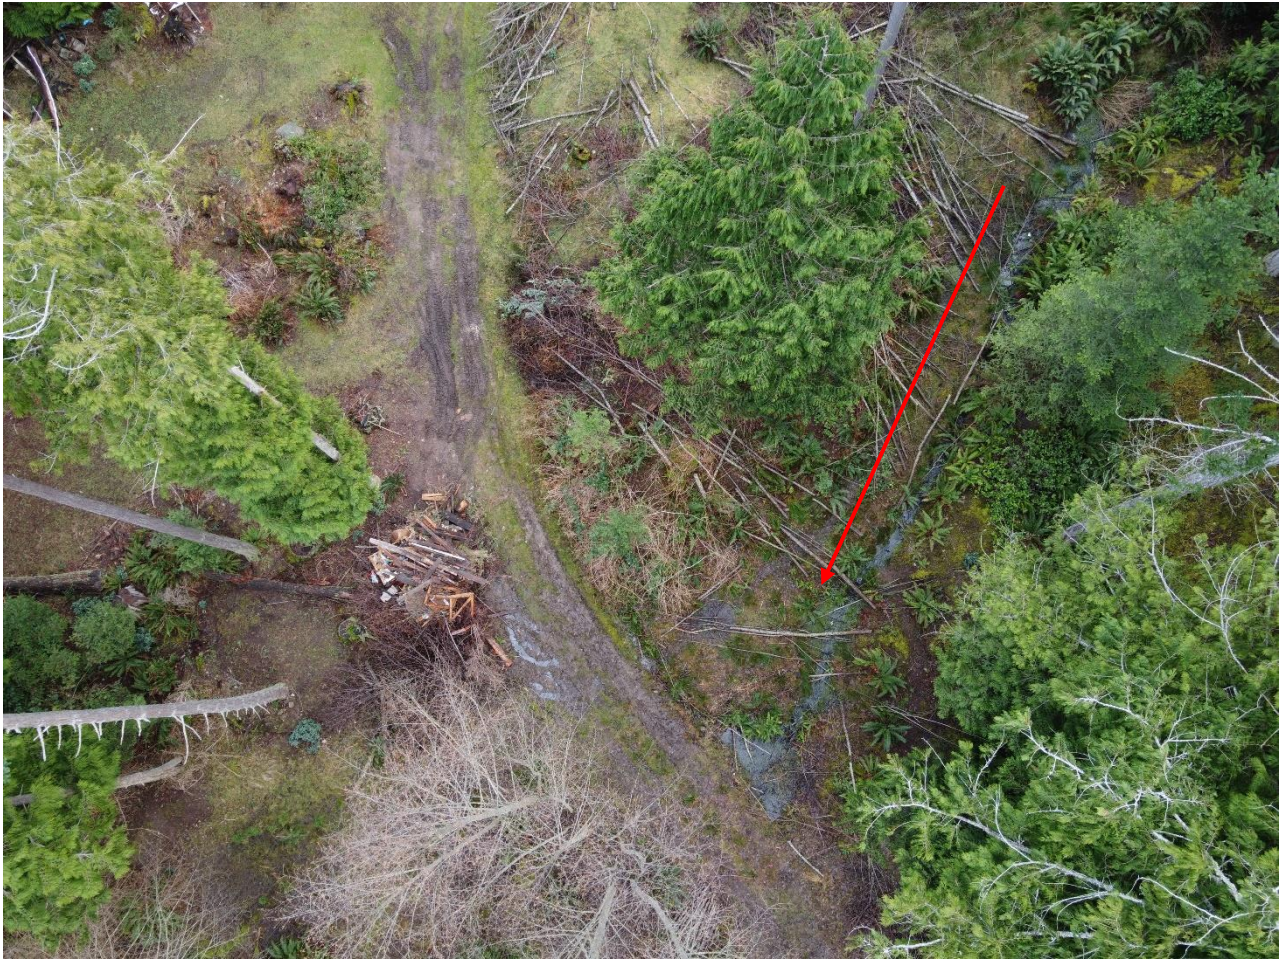
Figure 7. Old logging roads, compacted soil surfaces, and a deep ditch with flowing water (red arrow) could be removed to restore a forested cedar wetland in this location. The ditch concentrates and directs runoff onto the neighbouring properties to the north.

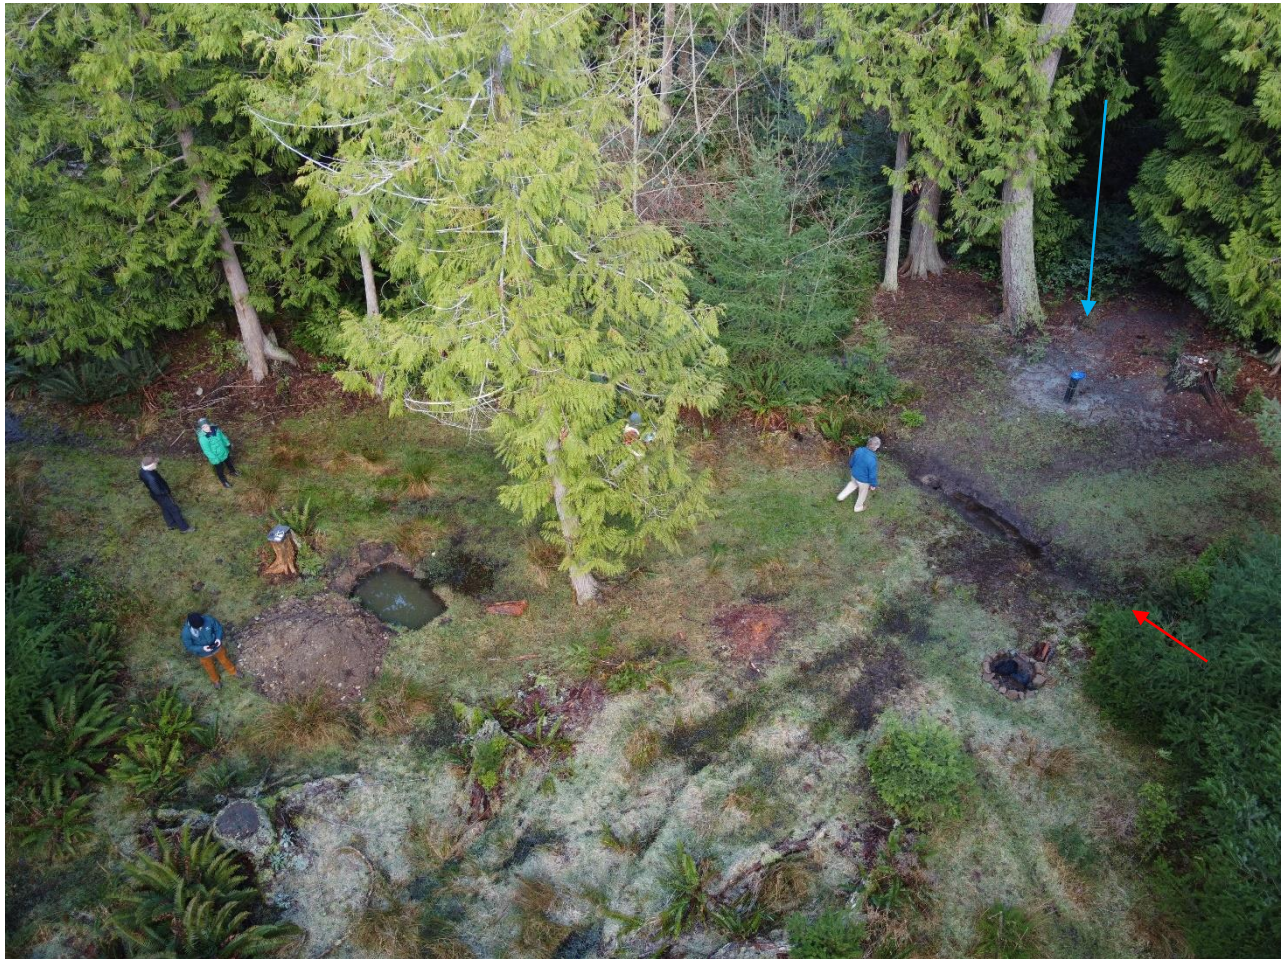
Figure 8. The ditch (red arrow) that crosses this open area near the well (blue arrow) would be disabled. The existing opening in the foreground would be used to build pond #1.

Two smaller, roughly parallel ditches were dug close to the location of the well ([Map](#)). These ditches would be disabled and removed as part of the construction of dwelling units 5-6 and 7-8, as well as through the construction of pond #1. This will help to restore the site's water storage capacity, moderate runoff and restore site's capacity to grow large cedar and other species of trees.

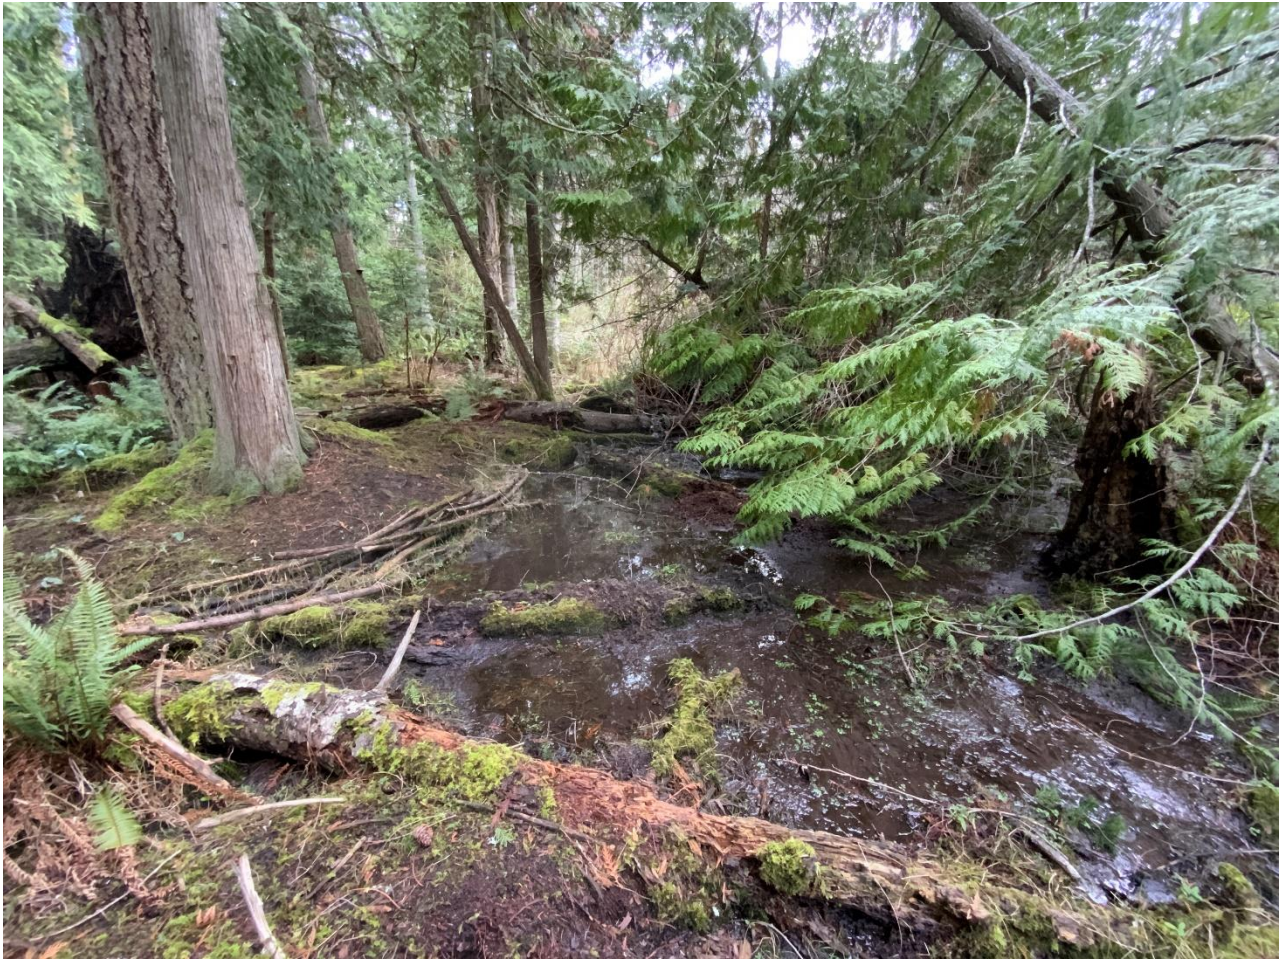
Figure 9 shows dispersed surface flow close to the northern boundary of Lot 2. This shows how water would flow through the forested wetland in periods of high flow after the ditches are removed.

Once the ditches are removed, there will still be surface flow through the area in the winter months. The flow of water will be across the surface, dispersed, and winding its way around and through trees. Figure 9 shows an example from a level area close to the northern boundary of Lot 2 that is beginning to function this way. Here the old ditches appear to have filled with sediment, and surface winter flows have returned to what would

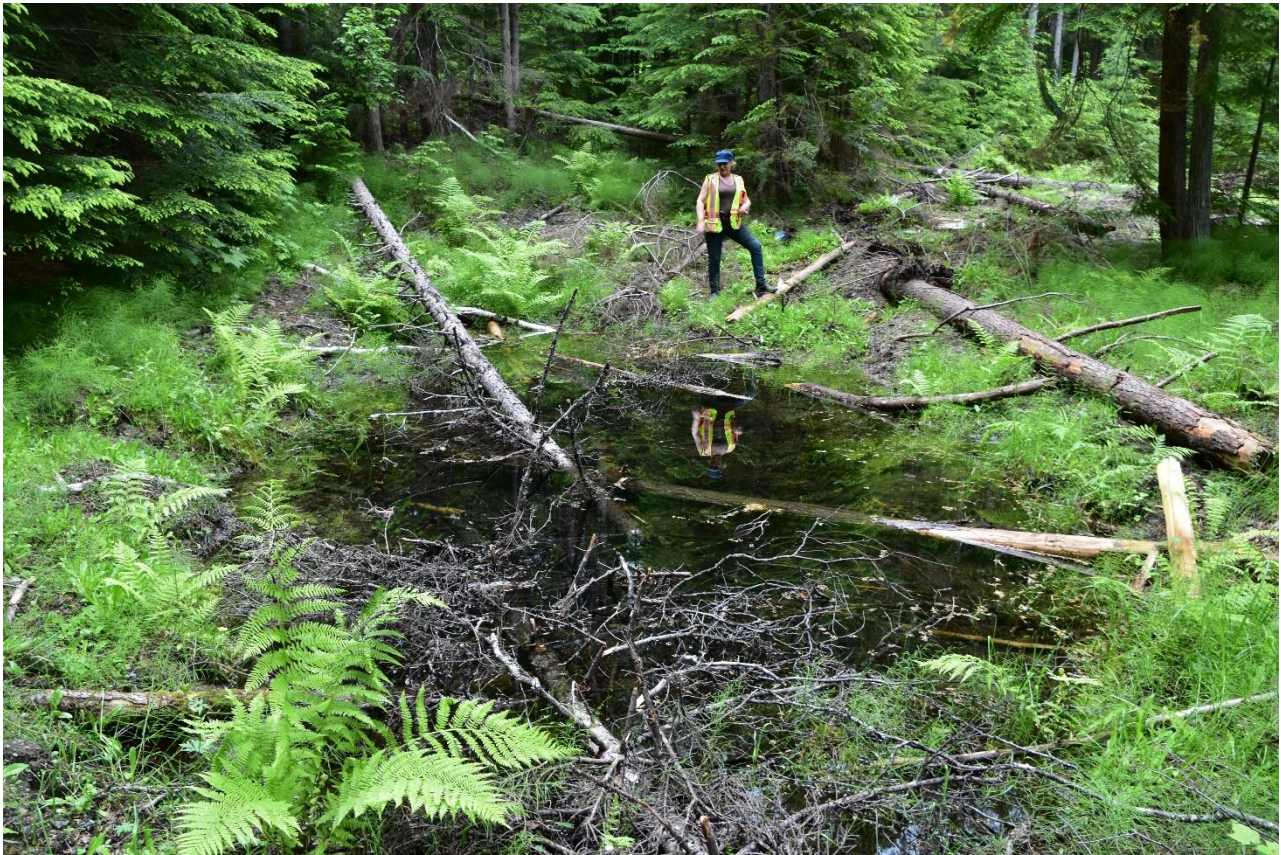
Figure 10. This wetland pond was built to in an old logging road at Snk'Mip Marsh in Hills, BC. It is one year old in the photo.

Figure 9 shows a pond that was built in a compacted gravel landing at the end of a logging road Snk'Mip Marsh near Hills BC. This wetland pool has a lot of good woody debris for wildlife and would be a suitable style for pond #2. For pond #1, which is close to the dwellings and where children will be playing, pieces of coarse woody debris that are child-friendly would be selected and placed to allow children to explore the pond. The

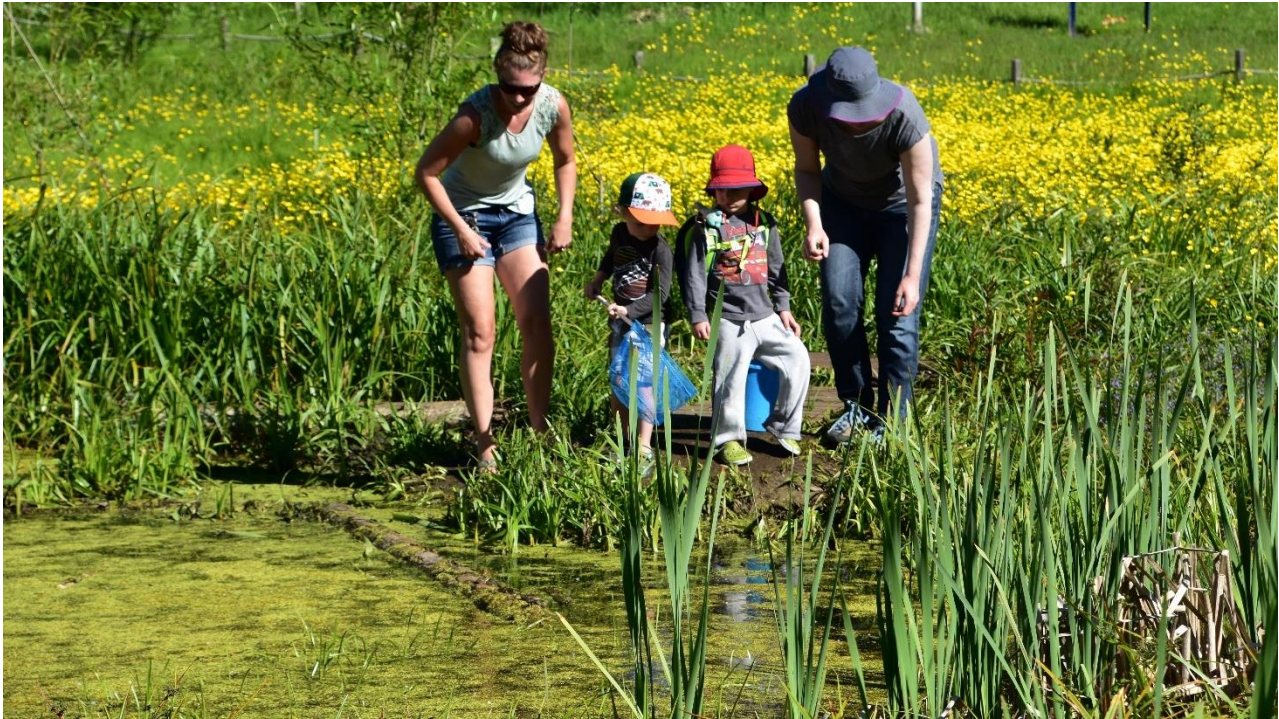
Figure 11. This wetland was designed and built by the author in Jubilee park in Rossland, BC. A peninsula was incorporated into the design to allow children to get close to the water and learn about pond life.

pond would be shallow, no more than 1.2 metres deep, with features like peninsulas and bays to help children closer to the water to explore the life of the pond.

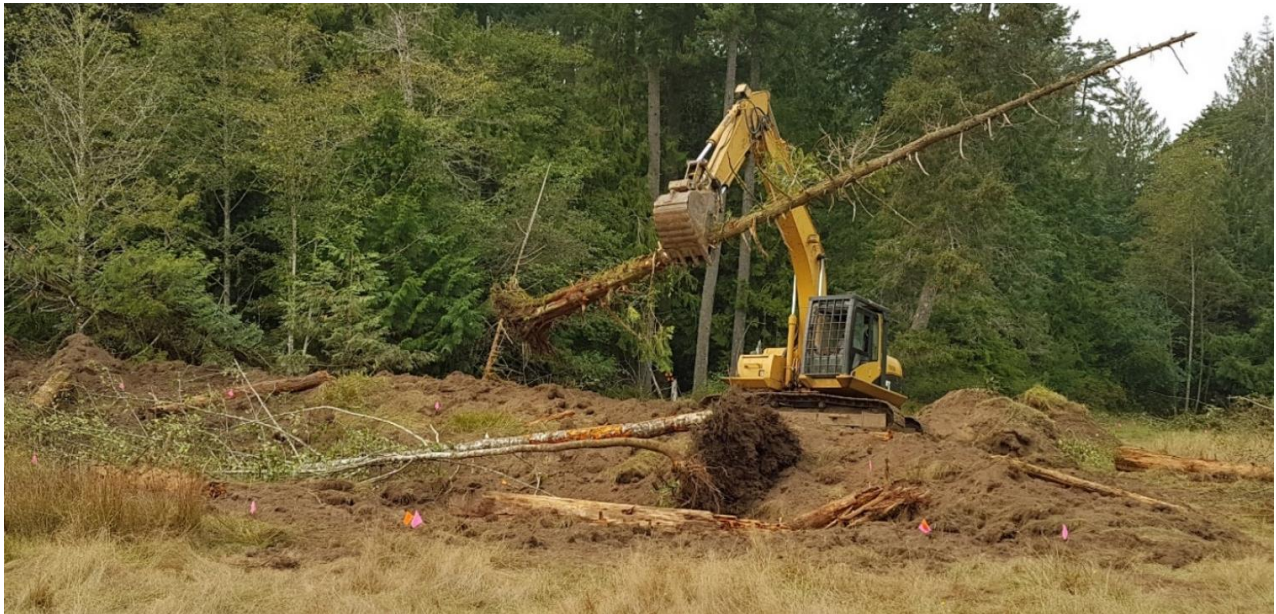
Figure 12 Adding coarse woody debris sourced on site to a wetland pond in September 2020 at Xwaaqw'um (Burgoyne Bay Provincial Park), Salt Spring Island.

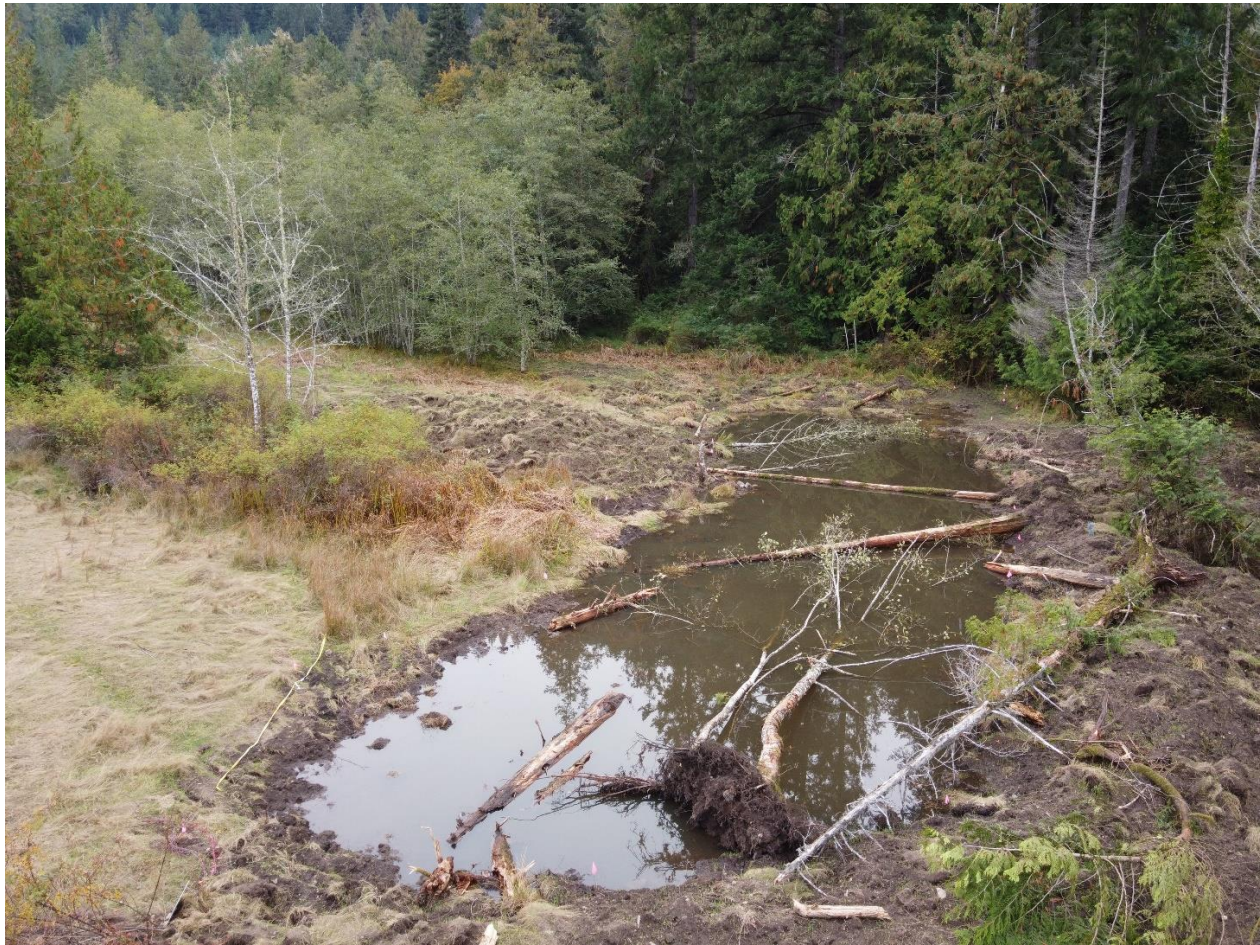
Figure 13. The same pond 2-weeks later after it filled with fall rains.
